## Geological trail around the city centre of St. Albans

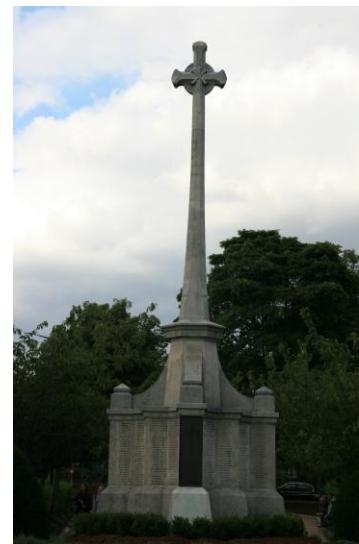
**START:** The War Memorial, at the north end of St Peter's Street is built of **Portland Limestone** (Isle of Portland, Dorset) showing many fragments of fossil shells. Cross St. Peter's Street.

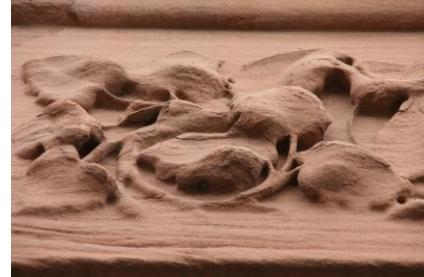
**8<sup>th</sup> & 9<sup>th</sup> stops:** NatWest Bank. The ground floor and window surrounds of the higher floors are built of red **Sherwood (or Bunter) Sandstone** (Mansfield, Nottinghamshire).

This Triassic rock is quite soft and easy to carve, but weathers readily; in particular the carvings above the windows are badly deteriorated. Next door is Waterstones whose shop front is faced on either side with a pale grey variety of **larvikite** (Norway). Continue along St Peter's Street until the traffic lights, cross Victoria Street into Chequer Street.

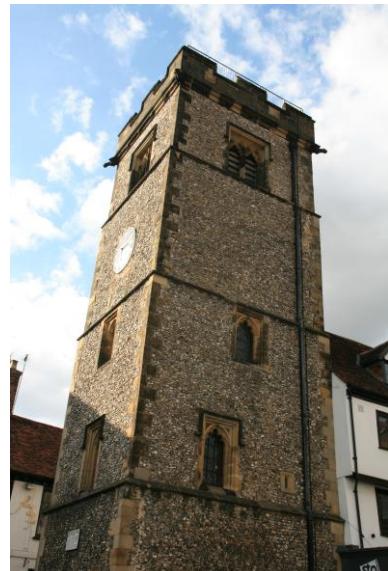
**11<sup>th</sup> stop:** Clock Tower, which is an early 15<sup>th</sup> Century curfew tower build mainly of dressed **flint** from the local Chalk, but with quoins of Carboniferous sandstone, probably a Coal Measure sandstone from the Bradford area, W. Yorkshire. Among the flints are also a few pieces of **Hertfordshire Puddingstone**. Note the way this hard rock has fractured; the silica matrix between the flint pebbles is so hard that the fracture surface has cut straight through the pebbles. The rock is from beds of sand and clay (the Reading beds) overlying the local Chalk; patches of flint pebbles were deposited within the Reading Beds by rivers and later became cemented by precipitation of silica between the pebbles. Because it is so hard, puddingstone can take a high polish and then shows a range of attractive colours. Turn left onto High Street.
